**Flood Control Project Maintenance**  
**2016 Structure Summary Report**  
**Overall Unit and Item Ratings**

**Merced Streams Group**

**Black Rascal Creek Drop Structure**

**Levee Inspection Report By Mile - Structure 2016**

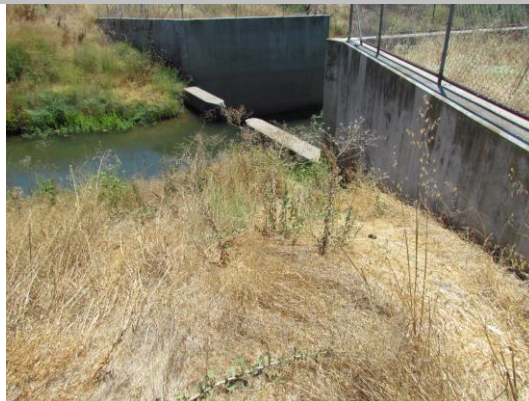
Photo 1 of 3 : ST\_2016\_NA0013\_28\_1\_20160822\_00001.jpg

Looking at the Black Rascal Creek Drop Structure from the upstream side of structure. Unit 1 Right bank.

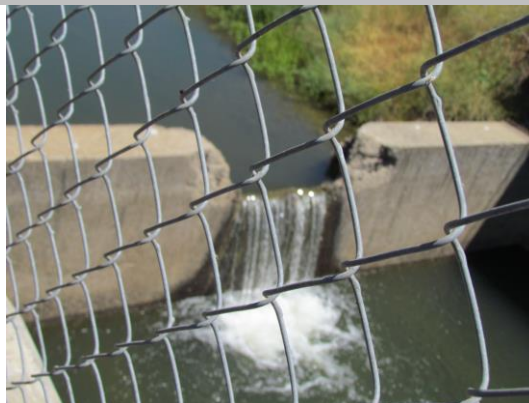
Photo 2 of 3 : ST\_2016\_NA0013\_28\_1\_20160822\_00002.jpg

Downstream side of Black Rascal Drop Structure from Unit 1.

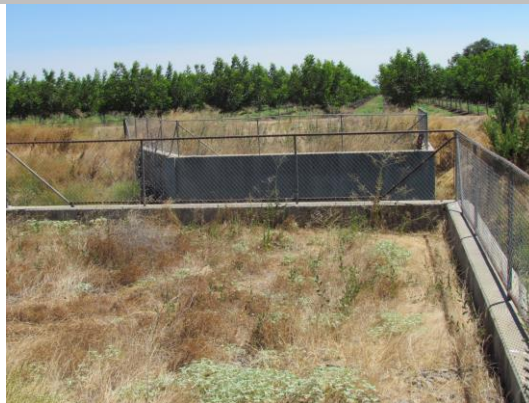
Photo 3 of 3 : ST\_2016\_NA0013\_28\_1\_20160822\_00003.jpg

This photo shows the safety fence around the structure Unit 1 and Unit 2.

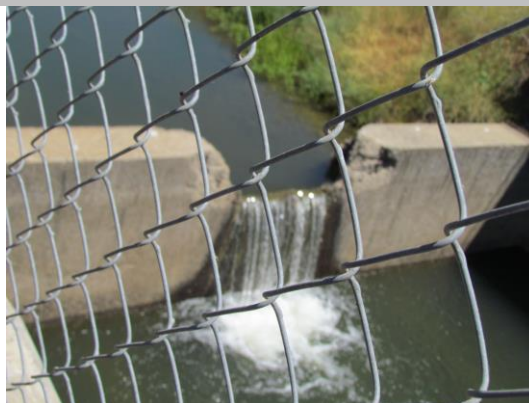
Photo 1 of 1 : ST\_2016\_NA0013\_28\_8\_20160822\_00006.jpg

LM Start	0.00	Rating **	A	Issue No.	8
LM End	0.00	Issue Type +	Ma	Location *	
Category	Structures & Concrete Lined Channels			GPS Latitude/Longitude	
				Start	End
Item	Culverts: Breaks / Holes / Cracks			37.314667 °	37.314667 °
				-120.396101 °	-120.396101 °
DWR ID	DWR_NA0013_28_t_2016_8				
Action/Comments					
Inspector Comments: The weir was notched out by the district to allow the water to flow downstream at lower water surface elevations.

This photo was used to show the downstream side of structure where the MID notched out a section in the concrete to allow water to flow through.

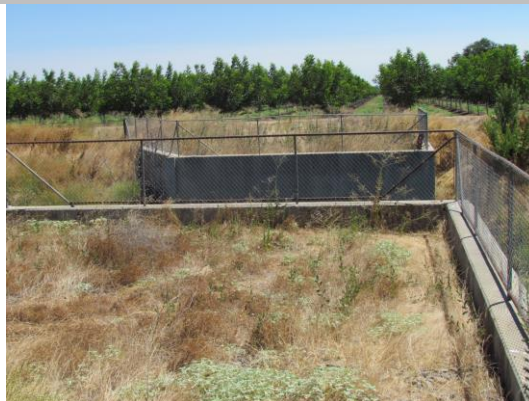
Photo 1 of 2 : ST\_2016\_NA0013\_28\_23\_20160901\_00007.jpg

LM Start	0.00	Rating **	A	Issue No.	23
LM End	0.00	Issue Type +	Ma	Location *	
Category	Structures & Concrete Lined Channels	GPS Latitude/Longitude			
		Start	End		
Item	Safety	37.314667 °		37.314667 °	
		-120.396101 °		-120.396101 °	
DWR ID	DWR_NA0013_28_t_2016_23				
Action/Comments					
Inspector Comments: There are no safety hazards at this location that caused a problem or that poses an immediate threat.

Safety fencing along top of structure.

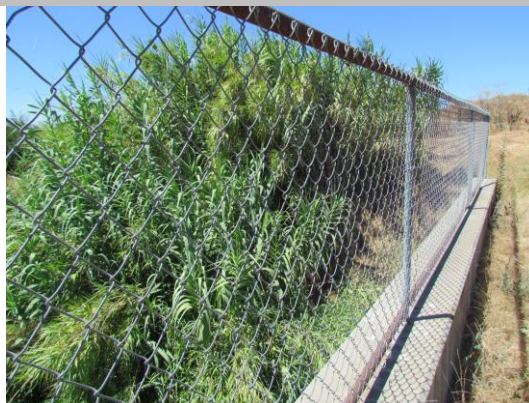
Photo 2 of 2 : ST\_2016\_NA0013\_28\_23\_20160901\_00008.jpg

Safety fencing along top of structure.

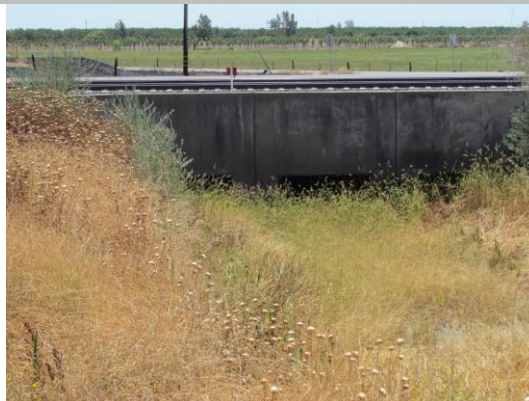
Photo 1 of 4 : ST\_2016\_NA0013\_51\_1\_20160830\_00001.jpg

Looking at the Owens Siphon Structure from up stream. 37.262901,-120.288081

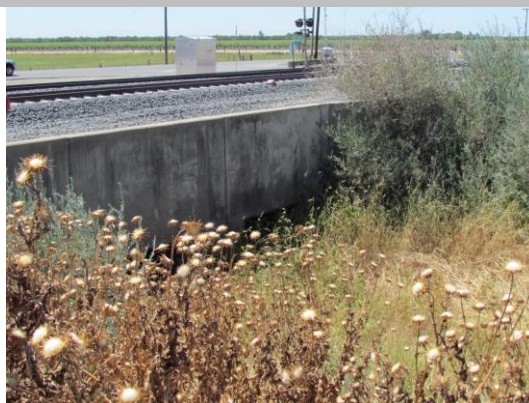
Photo 2 of 4 : ST\_2016\_NA0013\_51\_1\_20160830\_00002.jpg

Looking at the Owens Siphon structure. The vegetation has blocked two of the inlets. 37.262901,-120.288081

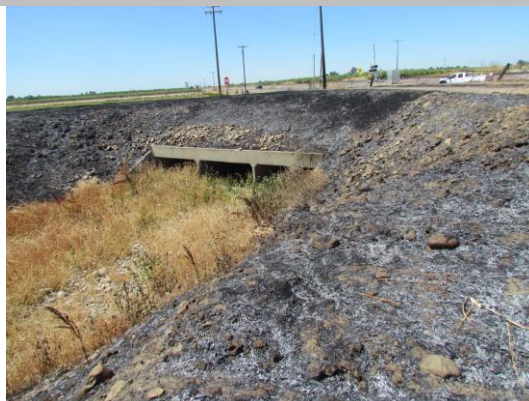
Photo 3 of 4 : ST\_2016\_NA0013\_51\_1\_20160831\_00007.jpg

Owens Creek Siphon Structure Outlet. 37.262317,-120.288333

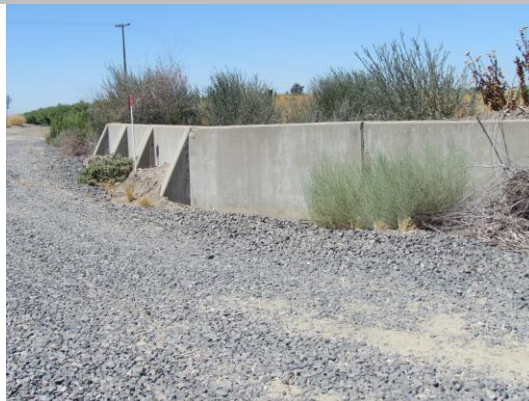
Photo 4 of 4 : ST\_2016\_NA0013\_51\_1\_20160831\_00009.jpg

Top of Owens Creek Siphon Structure Inlet. 37.262901,-120.288081

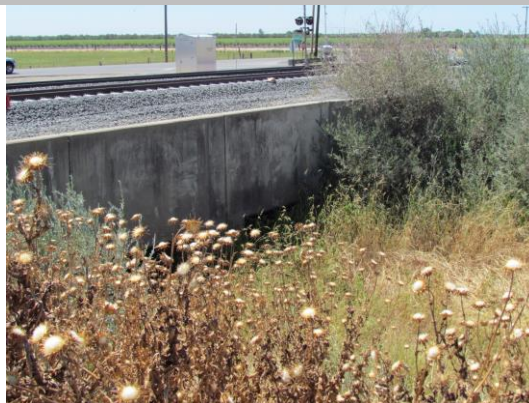
Photo 1 of 1 : ST\_2016\_NA0013\_51\_2\_20160830\_00003.jpg

Owens Creek Siphon Structure from upstream Inlet .

LM Start	0.00	Rating **	U	Issue No.	2
LM End	0.00	Issue Type +	Ma	Location *	
Category	Structures & Concrete Lined Channels	GPS Latitude/Longitude			
		Start		End	
Item	Vegetation & Obstructions	37.262901 °		37.262901 °	
		-120.288081 °		-120.288081 °	
DWR ID	DWR_NA0013_51_t_2016_2				
Action/Comments					
Inspector Comments: Remove the unwanted vegetation from within the structure.

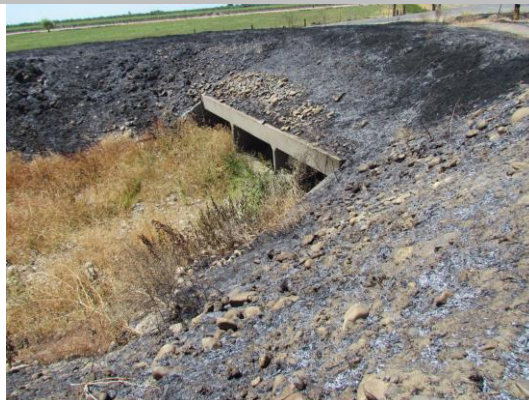
Photo 1 of 1 : ST\_2016\_NA0013\_51\_5\_20160831\_00010.jpg

LM Start	0.00	Rating **	A	Issue No.	5
LM End	0.00	Issue Type +	Ma	Location *	
Category	Structures & Concrete Lined Channels			GPS Latitude/Longitude	
				Start	End
Item	Revetments			37.262901 °	37.262901 °
				-120.880810 °	-120.288081 °
DWR ID	DWR_NA0013_51_t_2016_5				
Action/Comments					
Inspector Comments: The revetment is secure on the Outlet end of the structure.

Owens Creek Siphon Structure Outlet.

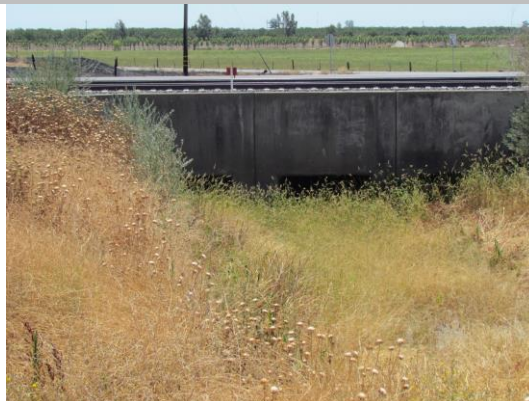
Photo 1 of 2 : ST\_2016\_NA0013\_51\_7\_20160830\_00004.jpg

The Inlets can not be seen completely due to tall weeds and brush growing in channel.

LM Start	0.00	Rating **	U	Issue No.	7
LM End	0.00	Issue Type +	Ma	Location *	
Category	Structures & Concrete Lined Channels			GPS Latitude/Longitude	
				Start	End
Item	Culverts: Inlets / Outlets			37.262901 °	37.262901 °
				-120.288081 °	-120.288081 °
DWR ID	DWR_NA0013_51_t_2016_7				
Action/Comments					
Inspector Comments: Remove the wild growth from in front of the Inlets before flood season.

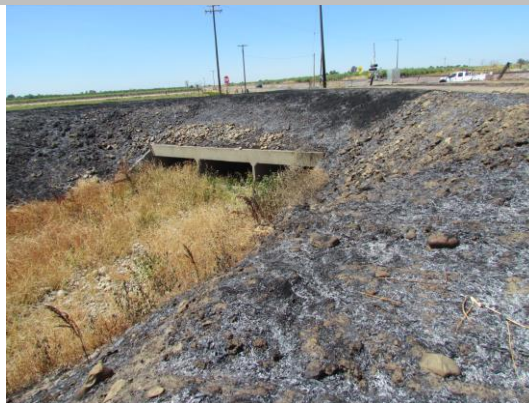
Photo 2 of 2 : ST\_2016\_NA0013\_51\_7\_20160831\_00008.jpg

The Outlet of Owens Creek Siphon Structure.
